# Falla de talud en la costa del Paraná, Argentina

## Slope failure at the Paraná shoreline, Argentina

*A 80000 m<sup>2</sup>, 3.5 m high embankment for a container yard was constructed on the right margin of the Paraná de las Palmas River in Zárate, Argentina. An additional temporary embankment, 3.5 m high, was put on top of it to speed up the consolidation process of underlying soft Postpampeano clays and organic soils. The construction of the preload embankment took about four months. The preload was delayed in a small area of 6000 m<sup>2</sup> because of harbour activities. Several months later, and using the same equipment, the contractor completed the preload embankment of this small area within ten days. One day after completion of the preload, a massive slope failure occurred. In this paper, the results of the analyses of the slope failure, the remediation action undertaken and some comments on the behavior of the soils at the Paraná shoreline are presented.*

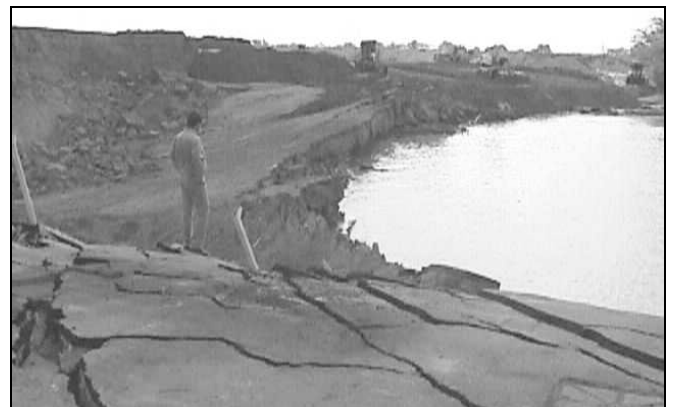
Figure 4. Sliding mass as seen from the wharf.

One day after the completion of this PE, a massive slope failure occurred. Within a few seconds a 100 m by 40 m surface settled more than 2.50 m. The recently placed preload

material, as well as the underlying permanent fill, fell into the river. The whole sliding area was flooded.

Figure 4 shows the sliding mass as seen from the wharf. The large inclination of the previously horizontal, flat surface is easily noticeable at the central left part of the picture. Fortunately, no people, equipment or any other facilities were at or near the sliding area.

- Remaining soils from the PE were removed the same day of the slope failure.
- The embankment surface immediately behind the failure area was reshaped, and a 1:1 slope surface was cut and sealed.
- Tension cracks behind the sliding mass were excavated and back filled with soil.
- The failure surface was trimmed and reshaped manually. Cracks within the failed area were carefully filled with sand and soil and sealed at surface.

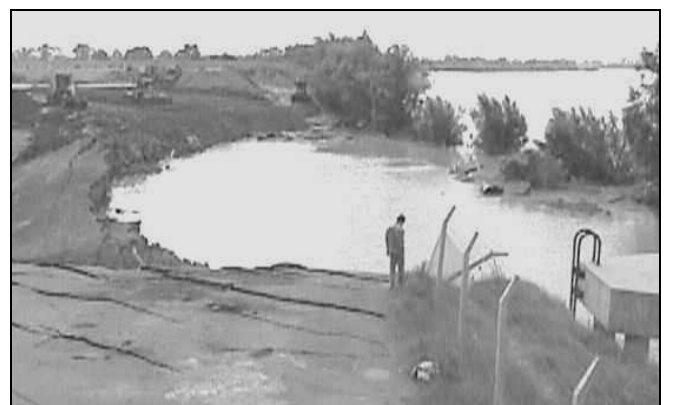
Figure 5. Coastline vegetation shifted 20 m into the river.

Figure 5 is another view from the same place, showing that the coastline vegetation moved some 20 m into the river. One of the authors is there for scaling reference.

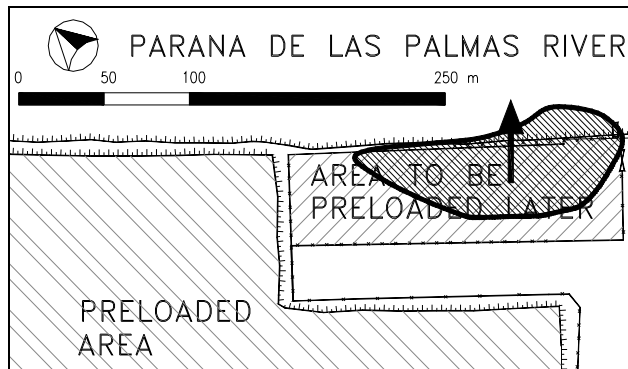
Figure 6. Sketch with sliding mass shown.

A topographic survey was conducted to evaluate the magnitude and depth of the failed soil mass. At the same time, some preliminary stability computations were performed, because there was an immediate need of a reliable undrained shear strength value of the soils at the assumed sliding surface. Figure 6 shows the sketch of the plan view and the failure area.

There was immediate agreement among the design engineers that the most probable cause of failure was a too high construction speed, because it was already known that the coastline slope was not stable under a fully undrained fill+PE surcharge. Water had been at its mean level the days before the failure occurred, so this particular source of soil overstressing was disregarded.

Therefore, the remediation program was limited to a slow placement of the fill after

compaction of the remaining materials, and a simple monitoring program to be maintained during the earthworks. No further inconveniences happened, and the embankment was completely repaired and, eventually, preloaded to the design height.

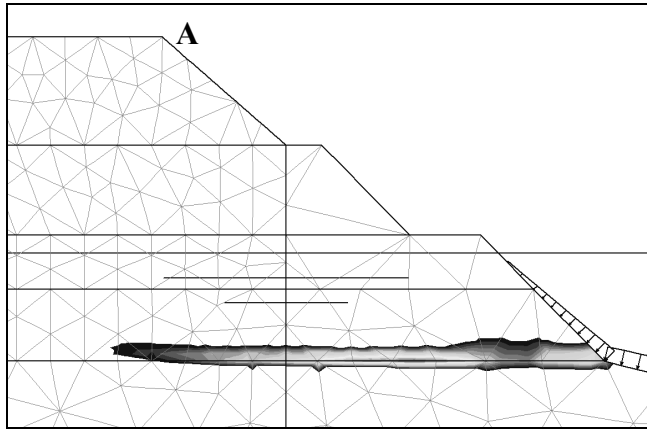
Figure 8. Strain increments at the onset of failure. Undrained analysis.

The partially consolidated model yielded no failure, whereas the fully undrained model failed at about 40%-60% of the full preload stage.

Onset of failure was not a slope stability problem but the squeeze of a very soft plastic layer, as shown in Figure 8, where only strain increments above mean value were plotted. This plot shows which portions of the model are increasing their velocity without control, and thus suggests where failure starts from.

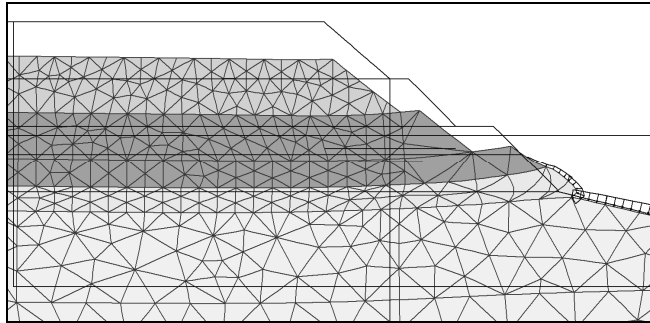
Figure 9. Settlements in partially drained analysis. Máx settlement is 1.25 m.

Figure 9 shows the deformed mesh of the second model. A 1.20 m max. settlement was achieved but movements eventually ceased, in a similar performance to that of reality.

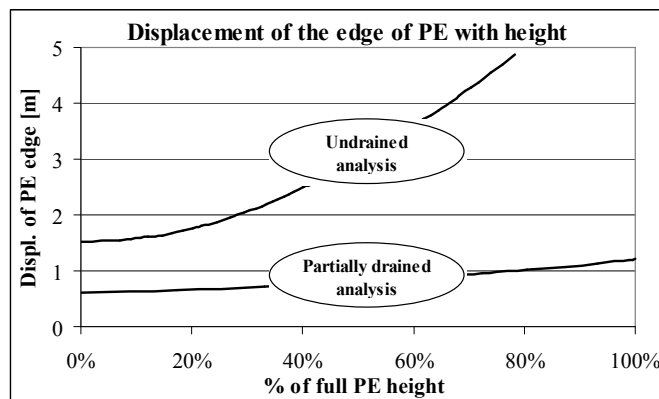
Figure 10. Displacement of the edge of PE during placement of the preload.

Figure 10 shows the displacement of the edge of the preload embankment, marked as “A” in Figure 8. It can be seen that total settlement for the partially drained model is 1.20 m, and that it's behaviour is stable, whereas the undrained analysis began to fail at about 40% of the full PE load.

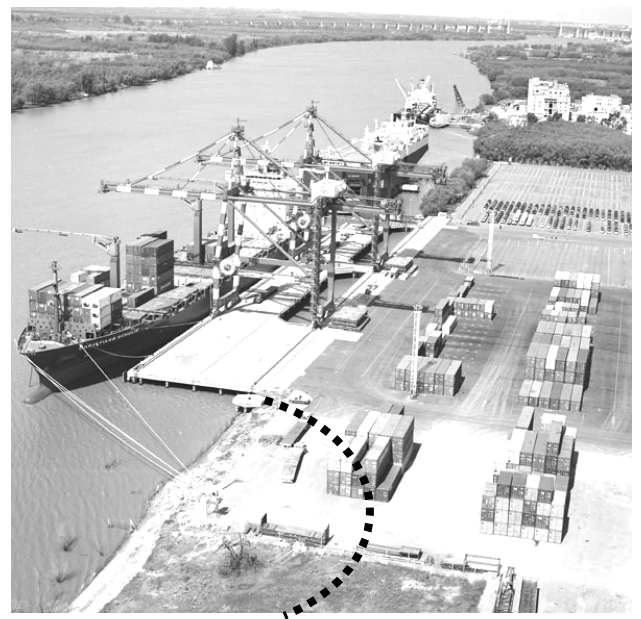
Figure 11. Aerial view of the site after rehabilitation works.

The combination of judgement, numerical analysis and interpretation of field data allowed for a safe completion of the project without further inconveniences. Figure 11 shows an aerial view of the wharf and yard today. A dotted arc shows the place where slope failure occurred, with some containers on it.
