# Falla de talud en la costa del Paraná, Argentina

## Slope failure at the Paraná shoreline, Argentina

*A 80000 m<sup>2</sup>, 3.5 m high embankment for a container yard was constructed on the right margin of the Paraná de las Palmas River in Zárate, Argentina. An additional temporary embankment, 3.5 m high, was put on top of it to speed up the consolidation process of underlying soft Postpampeano clays and organic soils. The construction of the preload embankment took about four months. The preload was delayed in a small area of 6000 m<sup>2</sup> because of harbour activities. Several months later, and using the same equipment, the contractor completed the preload embankment of this small area within ten days. One day after completion of the preload, a massive slope failure occurred. In this paper, the results of the analyses of the slope failure, the remediation action undertaken and some comments on the behavior of the soils at the Paraná shoreline are presented.*

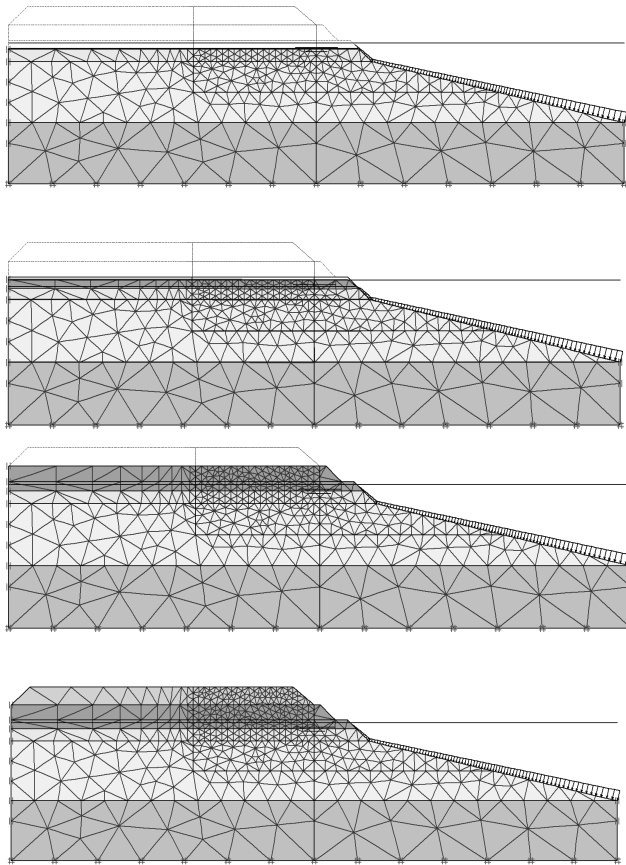
Figure 7. Mesh and construction stages.

The first construction stage is the natural shoreline, so no pore pressure build up was allowed there. Second stage is the placement of the first two meters of compacted fill, which happened long time before this project started, and was also modeled as a drained stage. Third stage is the placement of the permanent fill and the fourth stage is the placement of the preload embankment.

- 1 A fully undrained analysis, simulating the behaviour of the small embankment that failed.
- 2 A stepped undrained – consolidation analysis, where each construction stage was followed by a consolidation stage equivalent to a 30 day lag in construction time, thus simulating the real construction schedule.
